# **inFIRE CONFERENCE 2008**

**Damage To Consumer Appliances' and Electronics'  
Transformers and Fuses Under Simulated Fire Conditions**

Safety Engineering Laboratories, Inc.  
Donald Hoffmann, Ph.D., P.E., C.F.I.  
Presented by Erik Swonder, MSEE

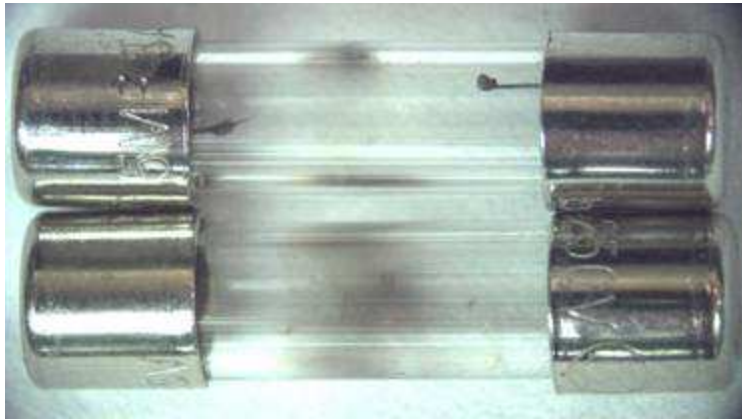
- Discoloration
  - Heat exposure resulted in uniform discoloration but varied in intensity
  - Opened electrically resulted in a ring, spot or band but varied in intensity
- Location of open ends of element
  - Both symmetric and asymmetric with respect to the center of the fuse

**Opened electrically**

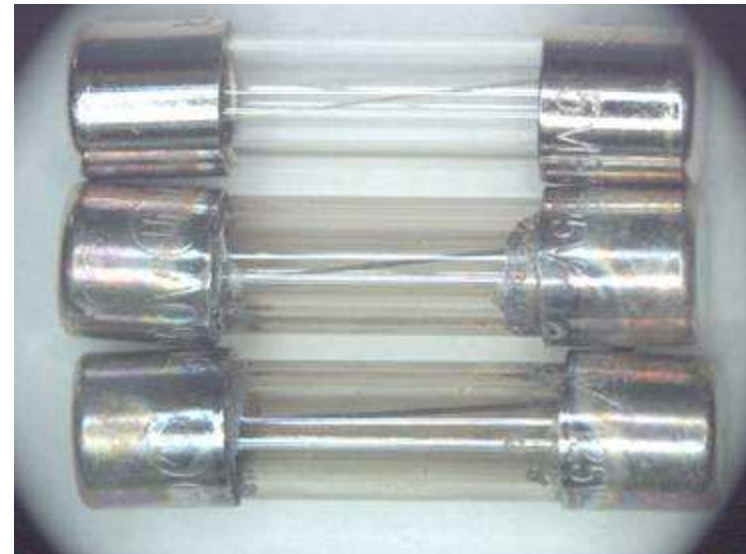
**Heat exposure**

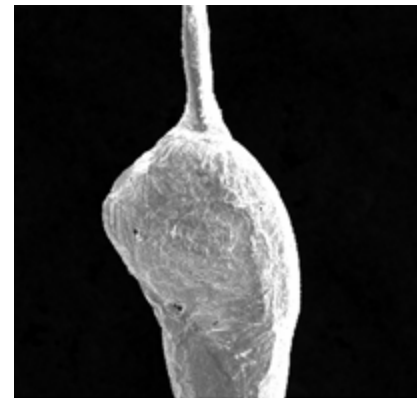
Fuse 5MF3 Test 3B

- Parting arc (bright flash)
- $T > T_m \text{ Cu} = 1983^\circ\text{F}$   
( $1084^\circ\text{C}$ )
- Rapid cooling
- Did not vaporize completely
- Localized damage to glass fibers of slow blow fuse

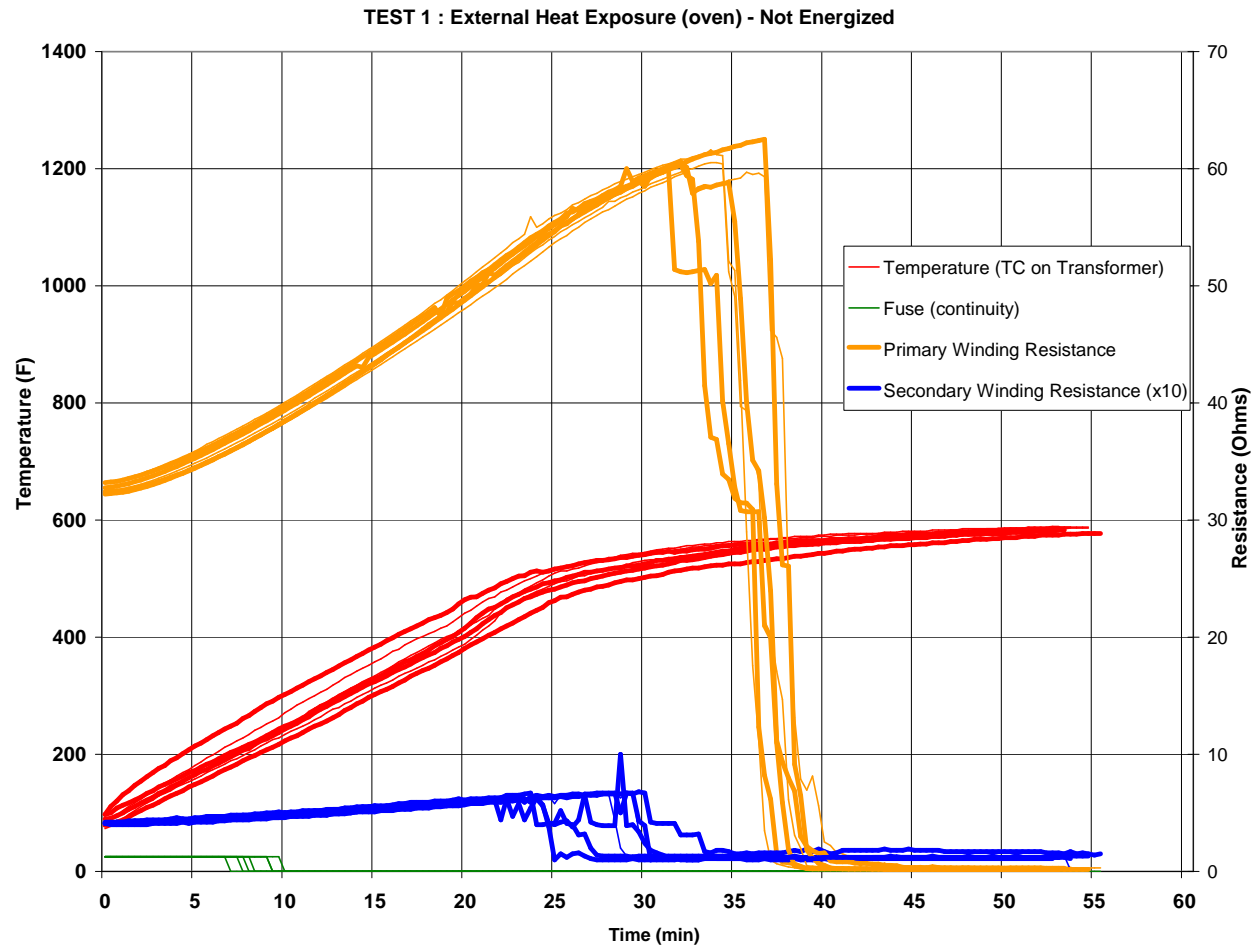
- Heated not energized

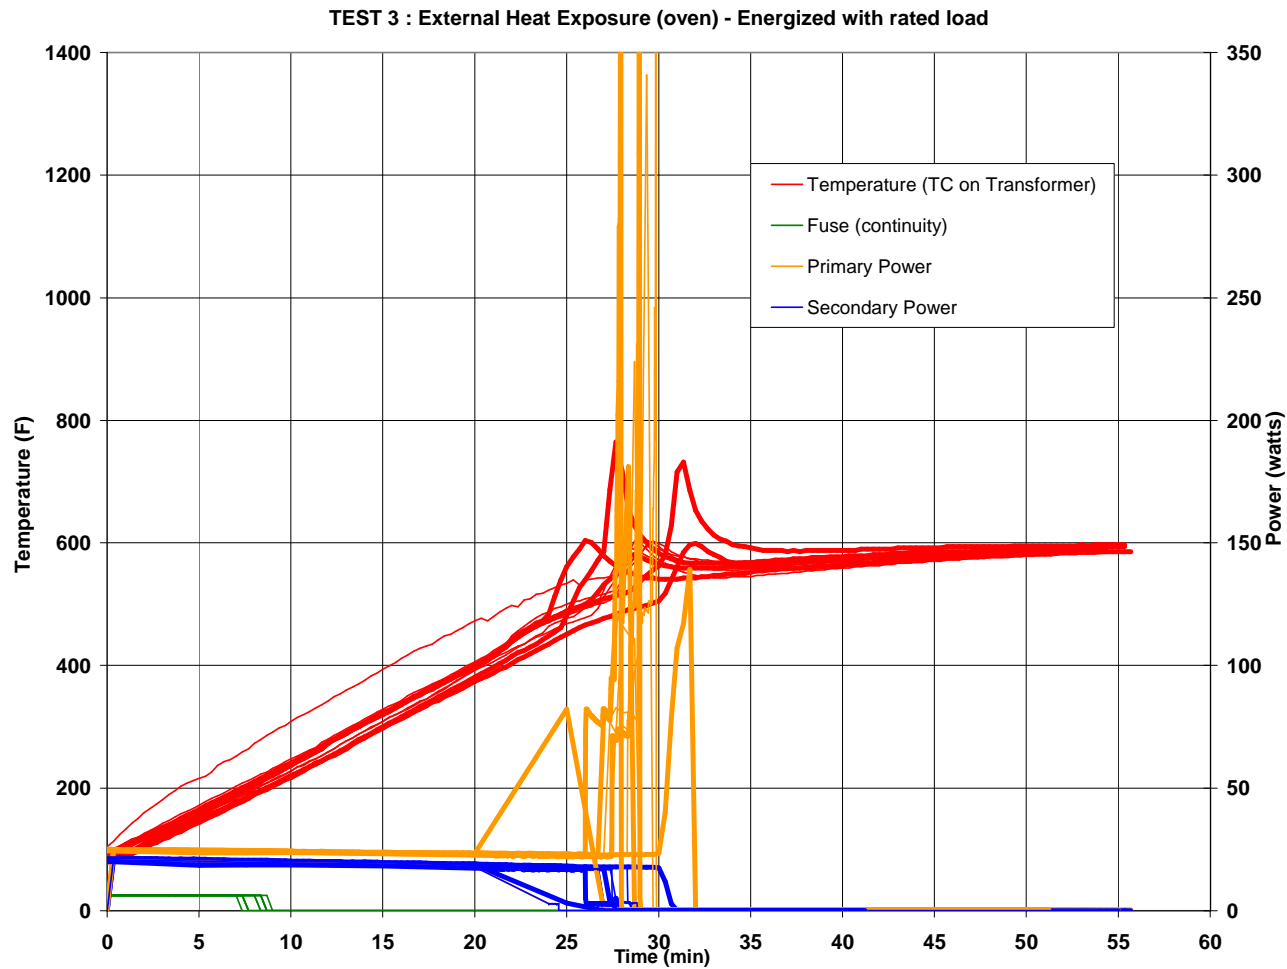
- Heated operating at rated load

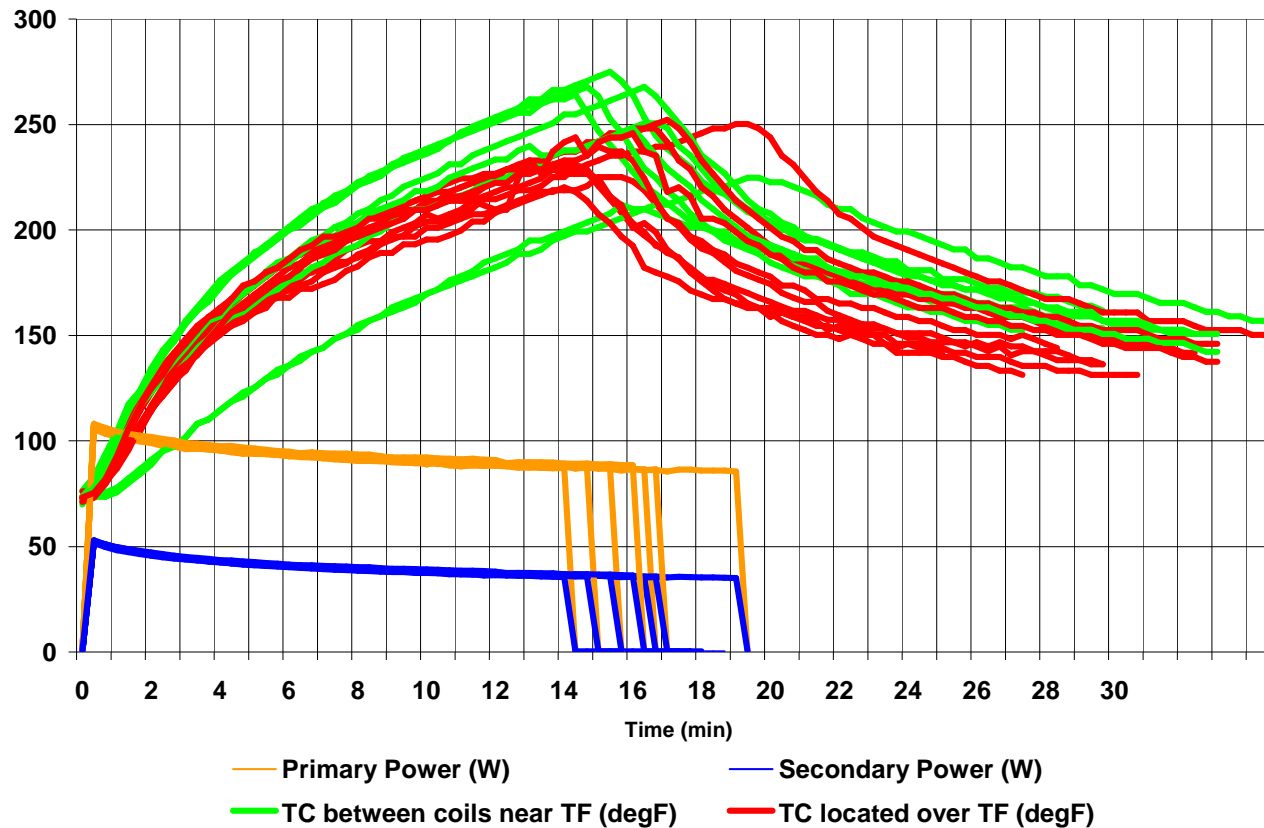
Test 8: Internal Heating with Thermal Fuse In Circuit (0.5 ohm sec. load)

- Internal Heating with Thermal Fuse

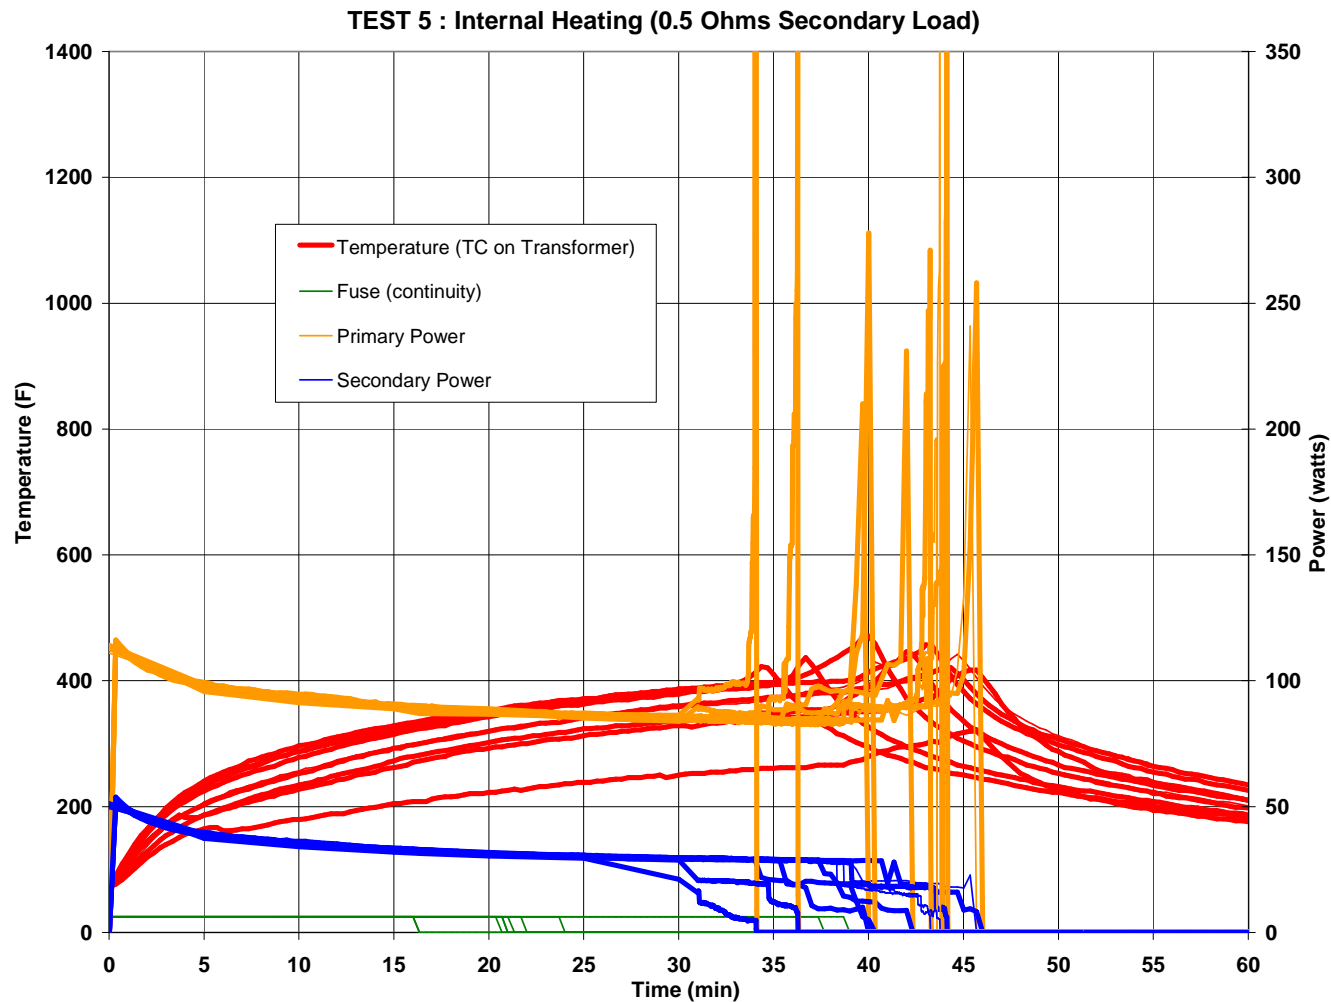
- Internal Heating

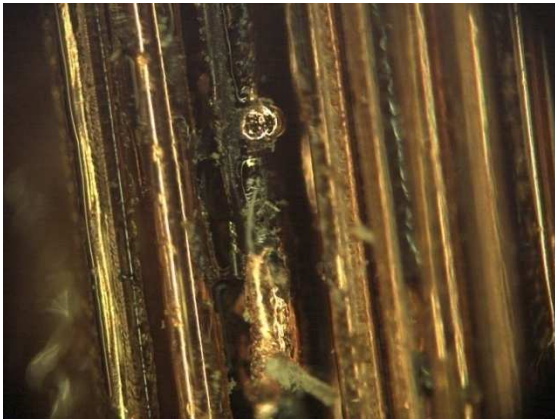
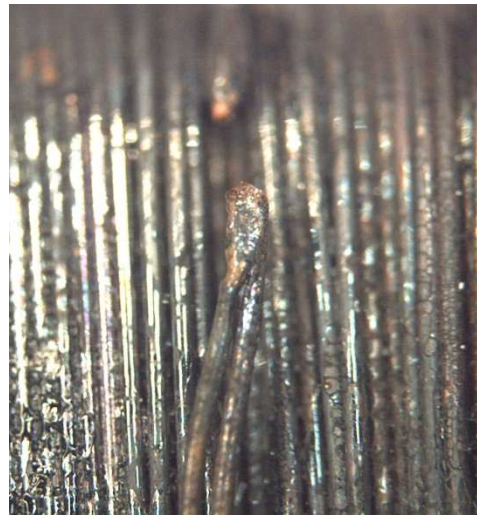
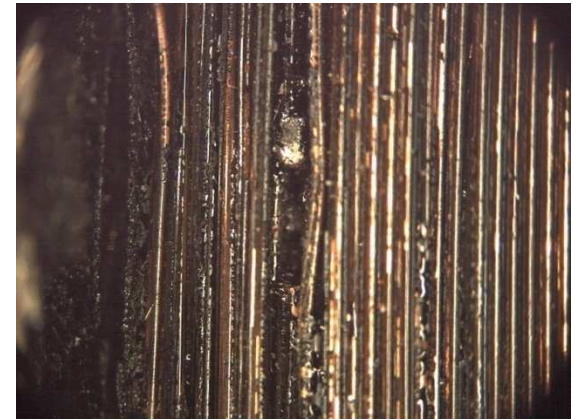
- External Heating Energized Rated Load
  - Resistance measurements all open (Primary)
  - Unwound
    - Localized arcing found between winding layers

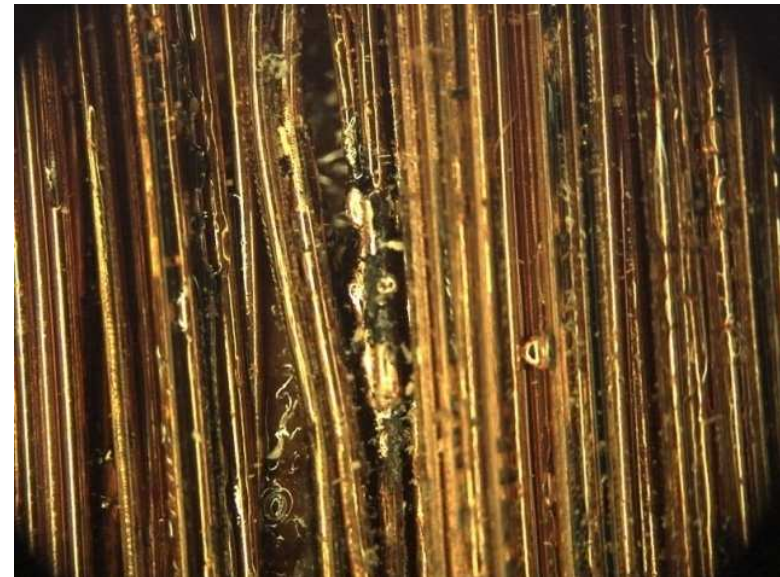
- Internal Heating
  - Fuse bypassed
  - Arcing found mostly on inner most layers
- Internal Heating in Fire
  - Fuse bypassed
  - Arcing on multiple layers from outside in
