# **inFIRE CONFERENCE 2008**

**Damage To Consumer Appliances' and Electronics'  
Transformers and Fuses Under Simulated Fire Conditions**

Safety Engineering Laboratories, Inc.  
Donald Hoffmann, Ph.D., P.E., C.F.I.  
Presented by Erik Swonder, MSEE

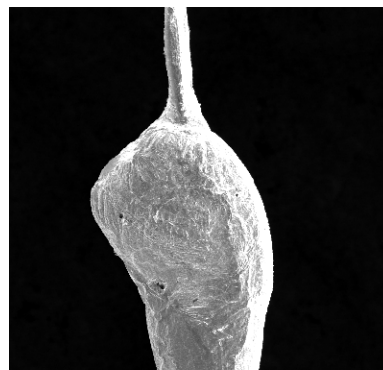
Fuse 5MF3 Test 3B | 200 µm |

- Parting arc (bright flash)
- $T > T_m \text{ Cu} = 1983^\circ\text{F}$   
( $1084^\circ\text{C}$ )
- Rapid cooling
- Did not vaporize completely
- Localized damage to glass fibers of slow blow fuse

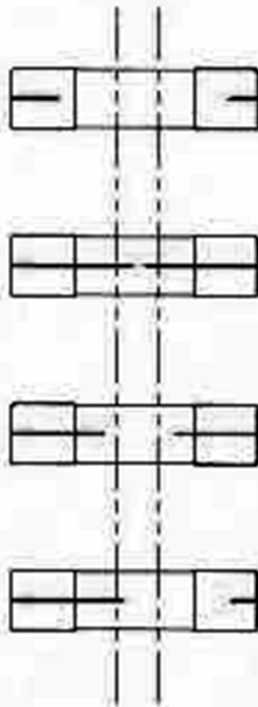
- Possible locations of the ends of a Fast Acting fuse element

$d > 10\text{mm}$ : Both ends located inside end caps.

$d < 3\text{mm}$ : Both ends located in approximate center of fuse.

$3\text{mm} < d < 10\text{mm}$ : Both ends located outside center  $1/3$  of glass case.

Asymmetric: one end in end cap

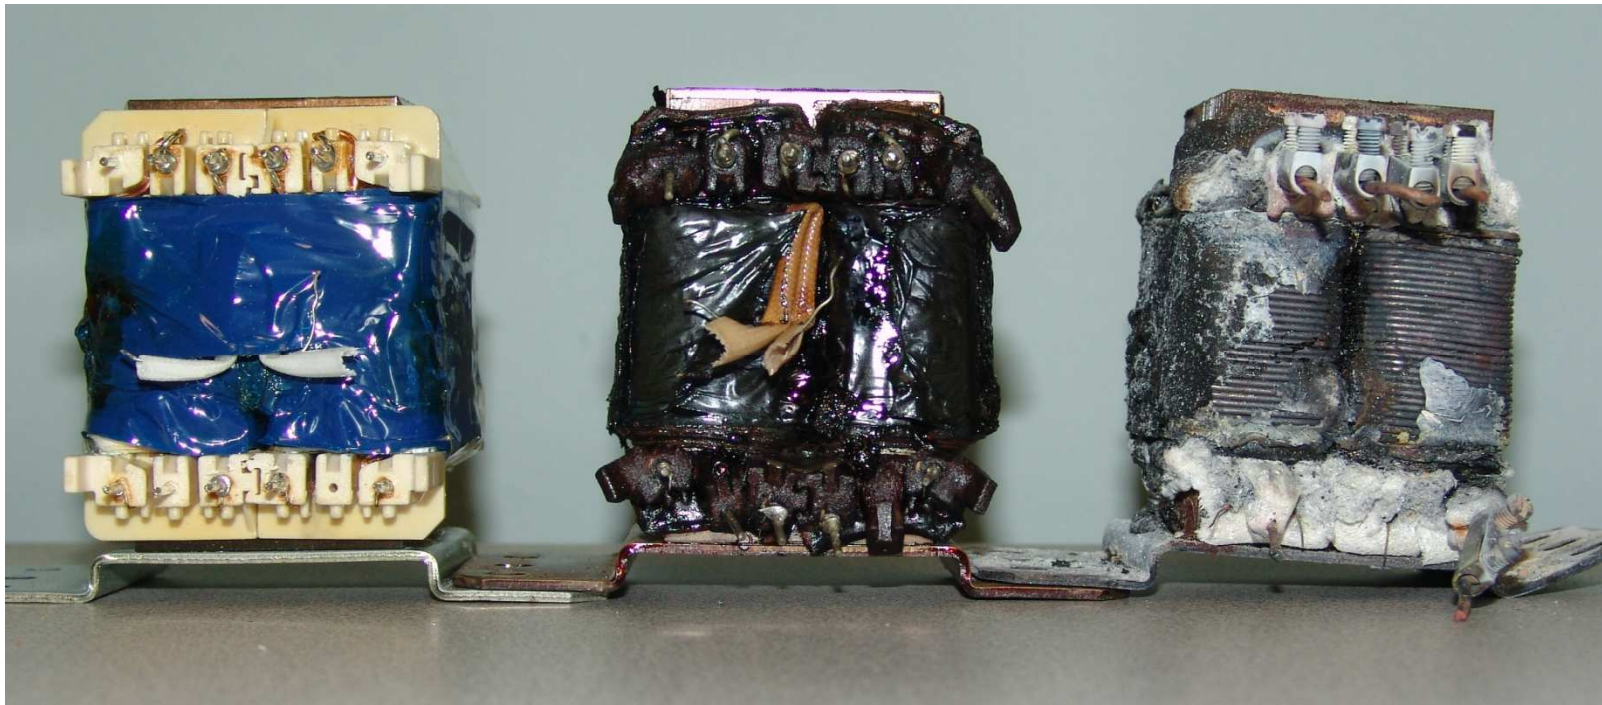
- Internal heating, Oven 600F, Fire Exposure

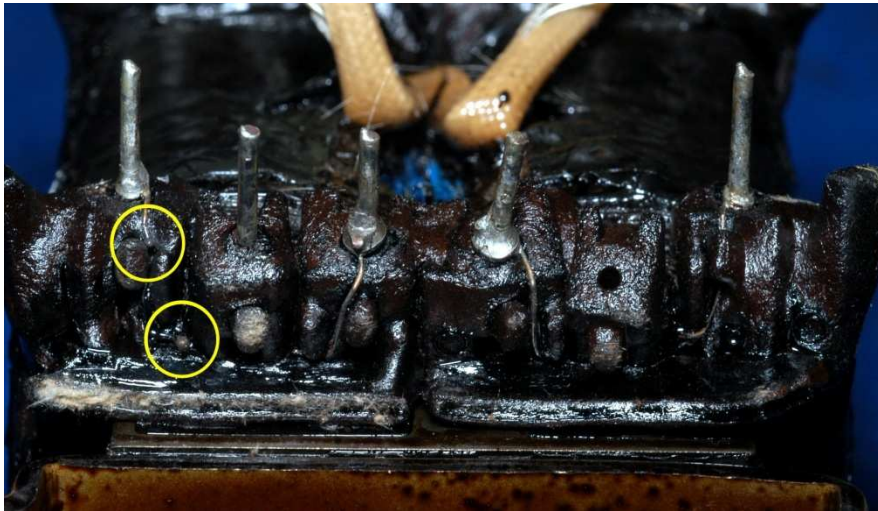
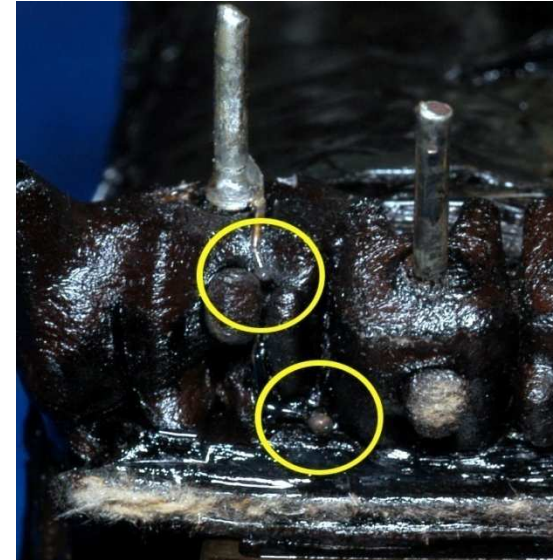
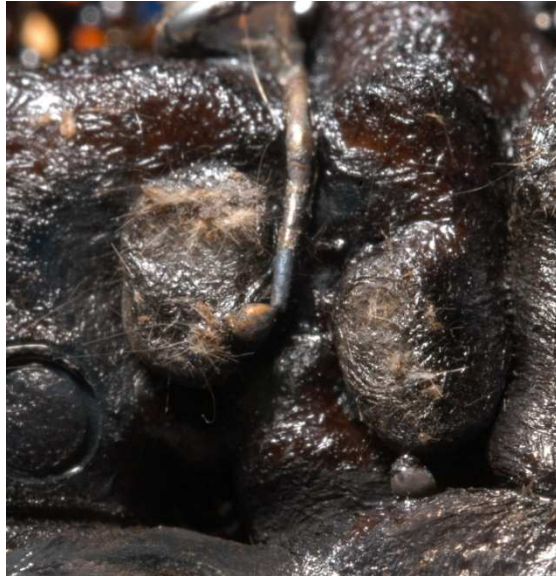
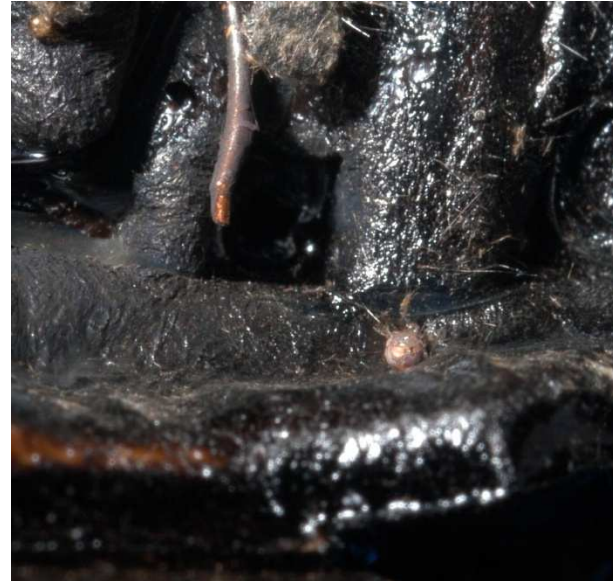
- Heated at rated load

- External Heating Energized Rated Load
  - Resistance measurements all open (Primary)
  - Unwound
    - Localized arcing found between winding layers

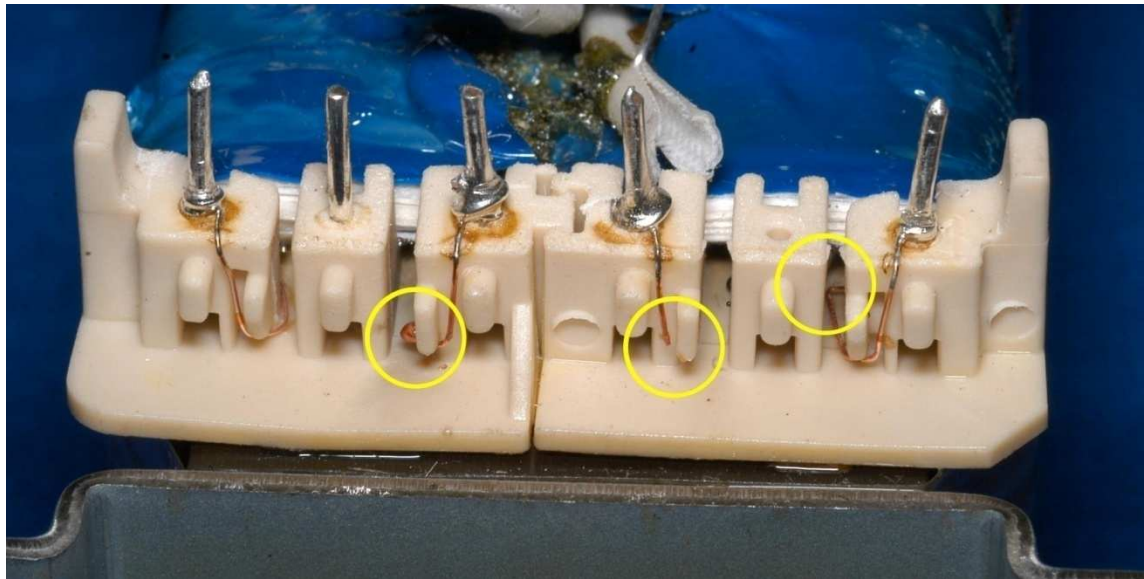
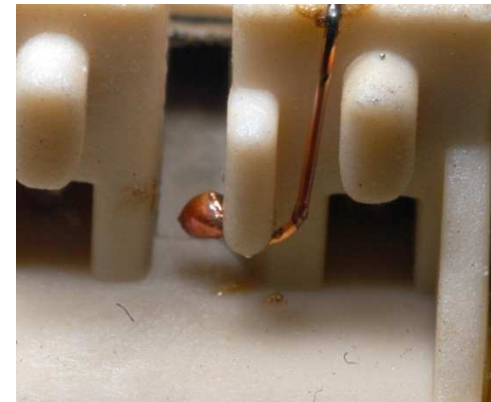
- Internal Heating

- Internal Heating
  - Fuse bypassed
  - Arcing found mostly on inner most layers
- Internal Heating in Fire
  - Fuse bypassed
  - Arcing on multiple layers from outside in

- Conclusion
  - Internal heating typically produced inner winding faults
  - External heating energized produced faulting throughout windings.
  - Location of electrical activity does not necessarily indicate failure mode
